# Degradation behavior of polymer materials in the high pressure hydrogen gas exposure

Polymer materials have an important role for the hydrogen storage cylinder. But it is not completely clarified how the high pressure hydrogen affects the polymer materials. The degradation behavior of the high density polyethylene molding exposed the high pressure H<sub>2</sub> gas is investigated by various analysis methods.

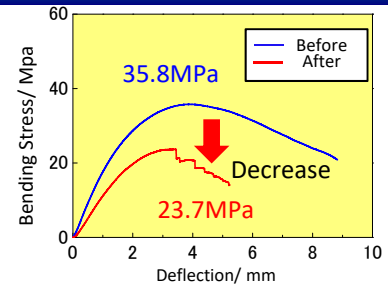
The area from the surface to about 4mm in depth whitened by the exposure test.

The bending strength was decreased and irregular stress liberation behavior was observed in the exposure sample.

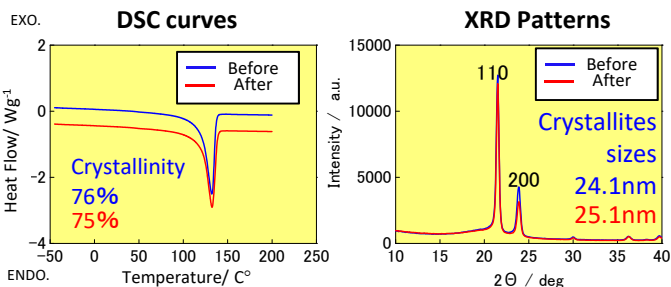
## Crystal structure analysis by DSC and XRD

The crystallinity was slightly decreased after the test.

The crystallites sizes became slightly larger after the test.

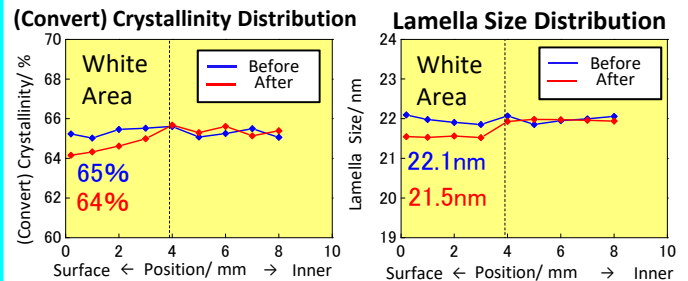
## Crystal structure distribution analysis by Raman spectroscopy

The (convert) crystallinity was decrease and lamella sizes became smaller in the white area.

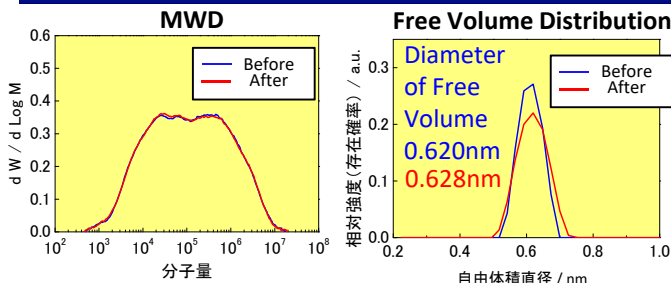
- Molecular Weight Distribution (MWD) by GPC
- Free Volume Distribution by PALS

The MWD was not change before and after the test.

The free volume sizes became slightly larger after the test.
