Structural evaluation of defects in PEFC catalyst layer by X-ray CT and SEM correlation microscopy in the meso-micro region

Toray Research Center introduced high sensitive SCMOS camera detector for soft X-ray microscope (XRM). By using XRM and X-ray CT, it became possible to investigate the process of catalyst layer defects, which is considered to be one of the reason of PEFC performance deterioration. "One-stop service" by correlation X-ray and scanning electron microscopy (X-ray CT & SEM) gave us the important structural informations.

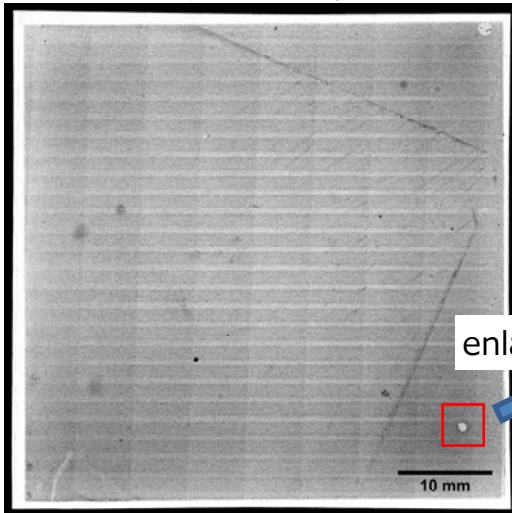
5 cm × 5 cm Whole transmission image of MEA

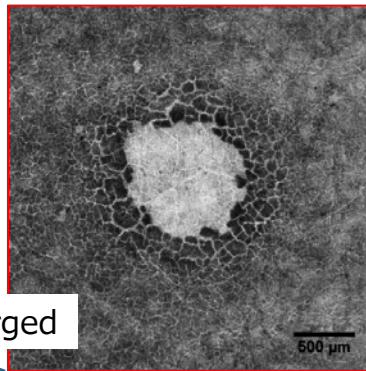
resolution : about 1 μm
Found the internal defect by transmission image

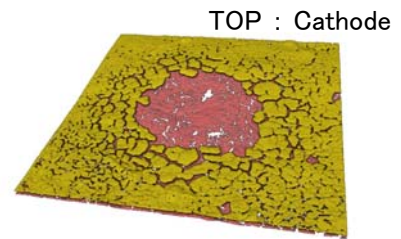
Remove GDL and MPL by image processing

BOTTOM : Anode

Clarify where there was no cathode

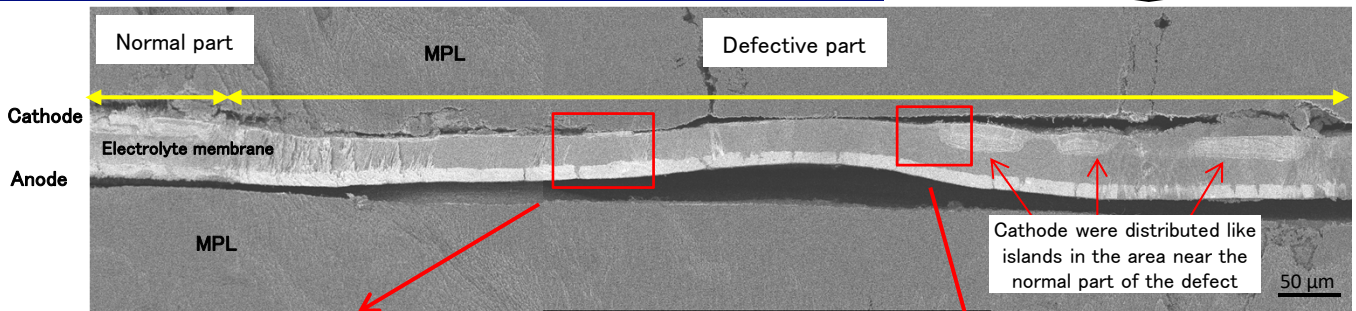
Cross-sectional SEM observation and SEM-EDX measurement of defective part

Pt + Si map (Yellow: Pt, Pink: Si)

- There were thin cathode remaining in defective part, confirmed the distribution of Si that were suspected of being mixed from outside, including in normal areas.
- The cause of the defect could be traced to the cause of the mixture of Si components.
