# TEM-EDX spectrometry of defective organic electroluminescence devices

The cause of the defect can be investigated by TEM-EDX analysis for the micro defective parts of organic with spectroscopic imaging-EL method.

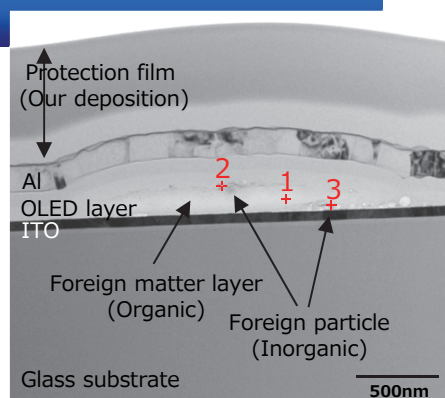
SEM image of surface

- In the bright spot, a foreign substance which has convex shape is observed under the OLED layer.
- From the EDX results, the foreign matter is found to be hydrocarbon organic matter (point1), which contain impurity elements such as Fe or In (point2, 3 of above image/table).

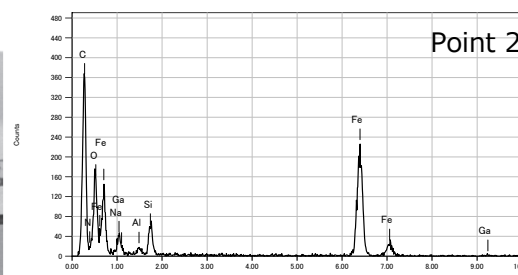
FIB-TEM image

| | C | N | O | Fe | In | Si | Na |
|---|---|---|---|---|---|---|---|
| Point 1 | 96.9 | 1.6 | 1.6 | — | — | — | — |
| Point 2 | 61.9 | 2.6 | 12.5 | 18.9 | — | 2.4 | 1.4 |
| Point 3 | 78.8 | 1.5 | 12.2 | — | 1.3 | 1.6 | 3.8 |

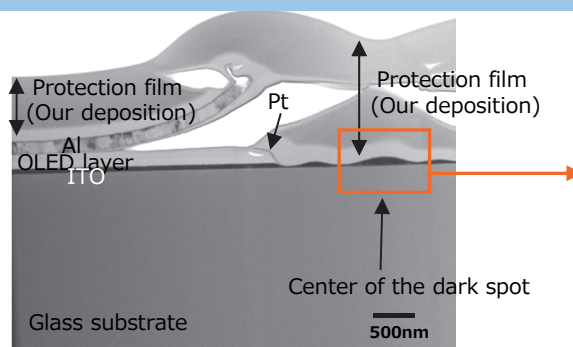
SEM image of surface

- The dark spot has a crater shape, and the Al electrode is swung up.
- In the center, there is no EL layer, and ITO is exposed. Unevenness in the thickness of ITO is observed.
- Among the central ITO, Na and Si were detected on the glass interface side (point5).

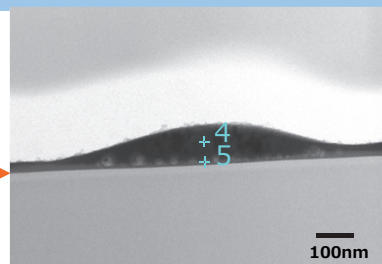
FIB-TEM image

| | In | O | Sn | Si | Na |
|---|---|---|---|---|---|
| Point 4 | 53.9 | 36.9 | 8.3 | — | 0.9 |
| Point 5 | 38.0 | 26.2 | 5.7 | 19.4 | 10.8 |
