Degradation behavior of polymer materials in the high pressure hydrogen gas exposure

Polymer materials have an important role for the hydrogen storage cylinder. But it is not completely clarified how the high pressure hydrogen affects the polymer materials. The degradation behavior of the high density polyethylene molding exposed the high pressure H₂ gas is investigated by various analysis methods.

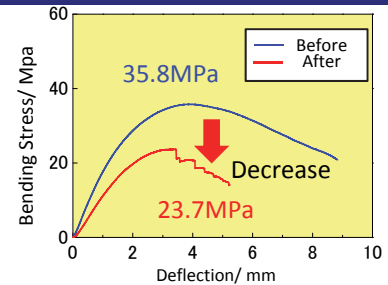
The area from the surface to about 4mm in depth whitened by the exposure test.

The bending strength was decreased and irregular stress liberation behavior was observed in the exposure sample.

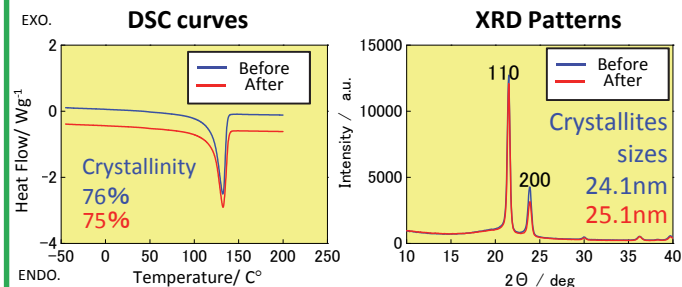
Crystal structure analysis by DSC and XRD

The crystallinity was slightly decreased after the test.

The crystallites sizes became slightly larger after the test.

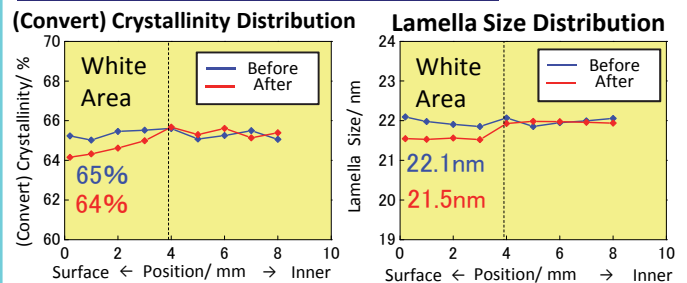
Crystal structure distribution analysis by Raman spectroscopy

The (convert) crystallinity was decrease and lamella sizes became smaller in the white area.

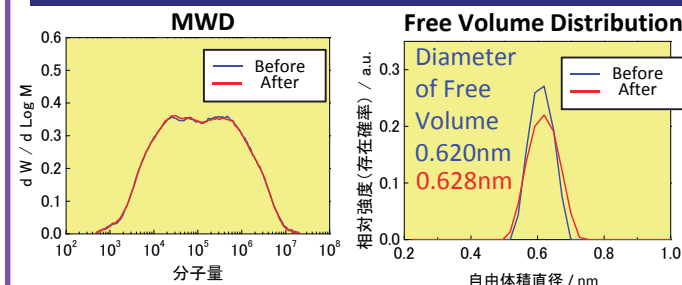
• Molecular Weight Distribution (MWD) by GPC
• Free Volume Distribution by PALS

The MWD was not change before and after the test.

The free volume sizes became slightly larger after the test.
