Characterization of dry etch-induced surface damage of β -Ga₂O₃ using OBF-STEM imaging

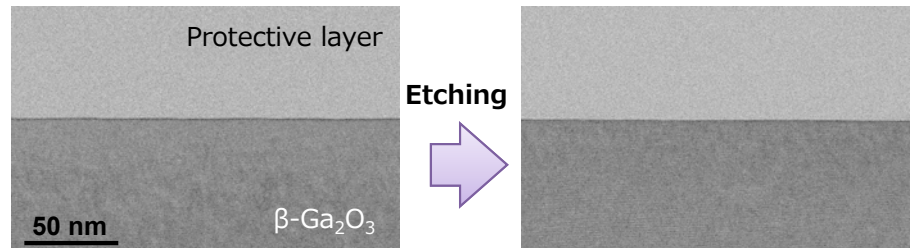
BF-STEM image

No large-size crystal defects near the surface of the β -Ga₂O₃ substrate

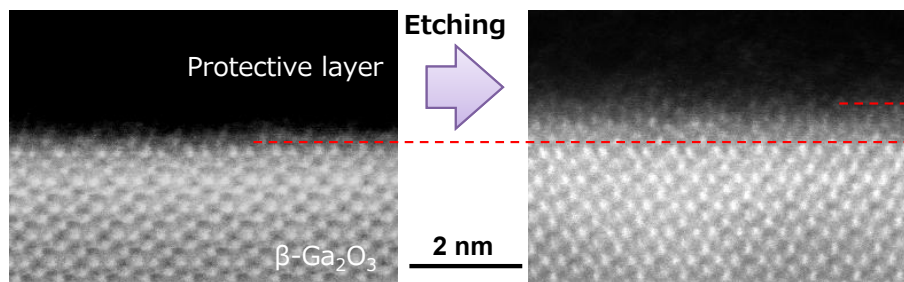
High-resolution HAADF-STEM image

Damage layer on the surface
(less than 1 nm)

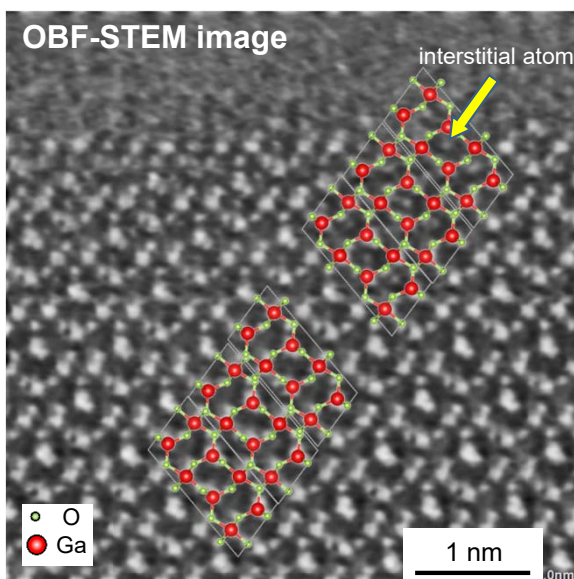
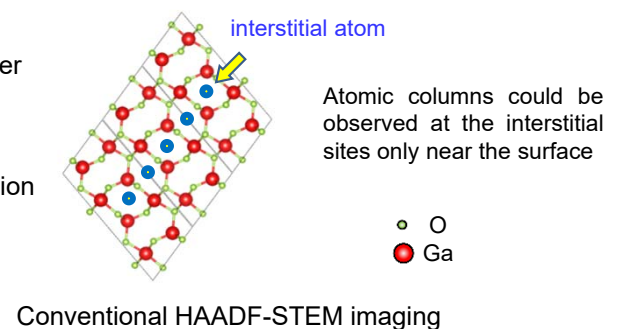
Structure in the damage layer was different from that inside substrate.
